INQUEST INTO THE DEATHS OF  
JOHANNA PAULINA MARIA HEYNEN  
AND MARILYN JEANNE MCDOUGALL

Finding of Inquest - Cause of Death

Inquest conducted by Mr Wayne Chivell, State Coroner, South Australia

**INQUEST INTO THE DEATHS OF  
JOHANNA HEYNEN & MARILYN MCDUGALL  
FINDING OF THE STATE CORONER**

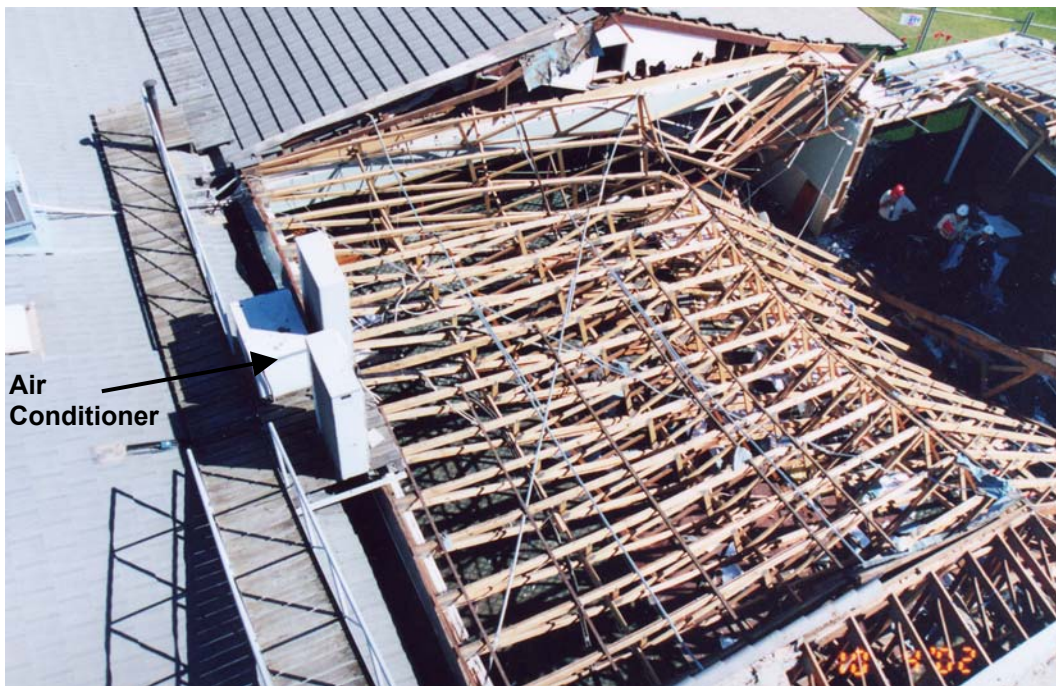
The failed Double Girder truss was observed to have suffered a profound fracture at its western support end and also along its top chord member in the first panel down from the apex. Two nailplate joints connecting the Pinus web members to the bottom chord member west of the apex had also failed.<sup>35</sup>

- 5.12. A photograph with an aerial view of the collapsed roof, looking generally west, is reproduced below. The western support end, where the double girder truss failed, is in the vicinity of where the workers are standing<sup>36</sup>.

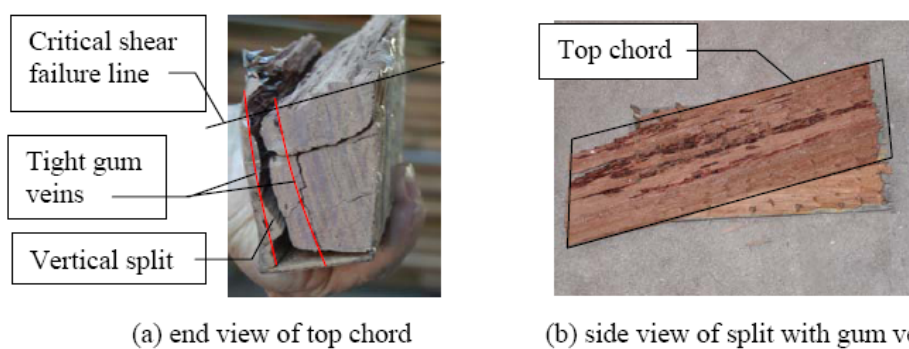
**Figure 7 – tight gum vein in southern truss top chord**

'As shown in Figure 7( a), the line of fracture is adjacent to, not through the gum vein. More than two thirds of the failure surface is through wood adjacent to the gum vein as seen by the lighter colour in Figure 7 (b).

The plane of the shear stresses causing failure in the heel area are perpendicular to the direction of the gum veins as indicated by the critical shear failure line in Figure 7(a).

There is no evidence of the wood fibres being dragged downwards. This would be the case if the failure was caused by shear stresses (The fibre distress can clearly be seen at the other shear failures, eg on the vertical shear failure in the heel shown in Figure 6.) This indicates that the fracture was not caused by large shear stresses typical of much of the wood in the heel zone. It is quite typical of wood subjected to a suddenly applied shock load typical of being dropped onto a hard surface.

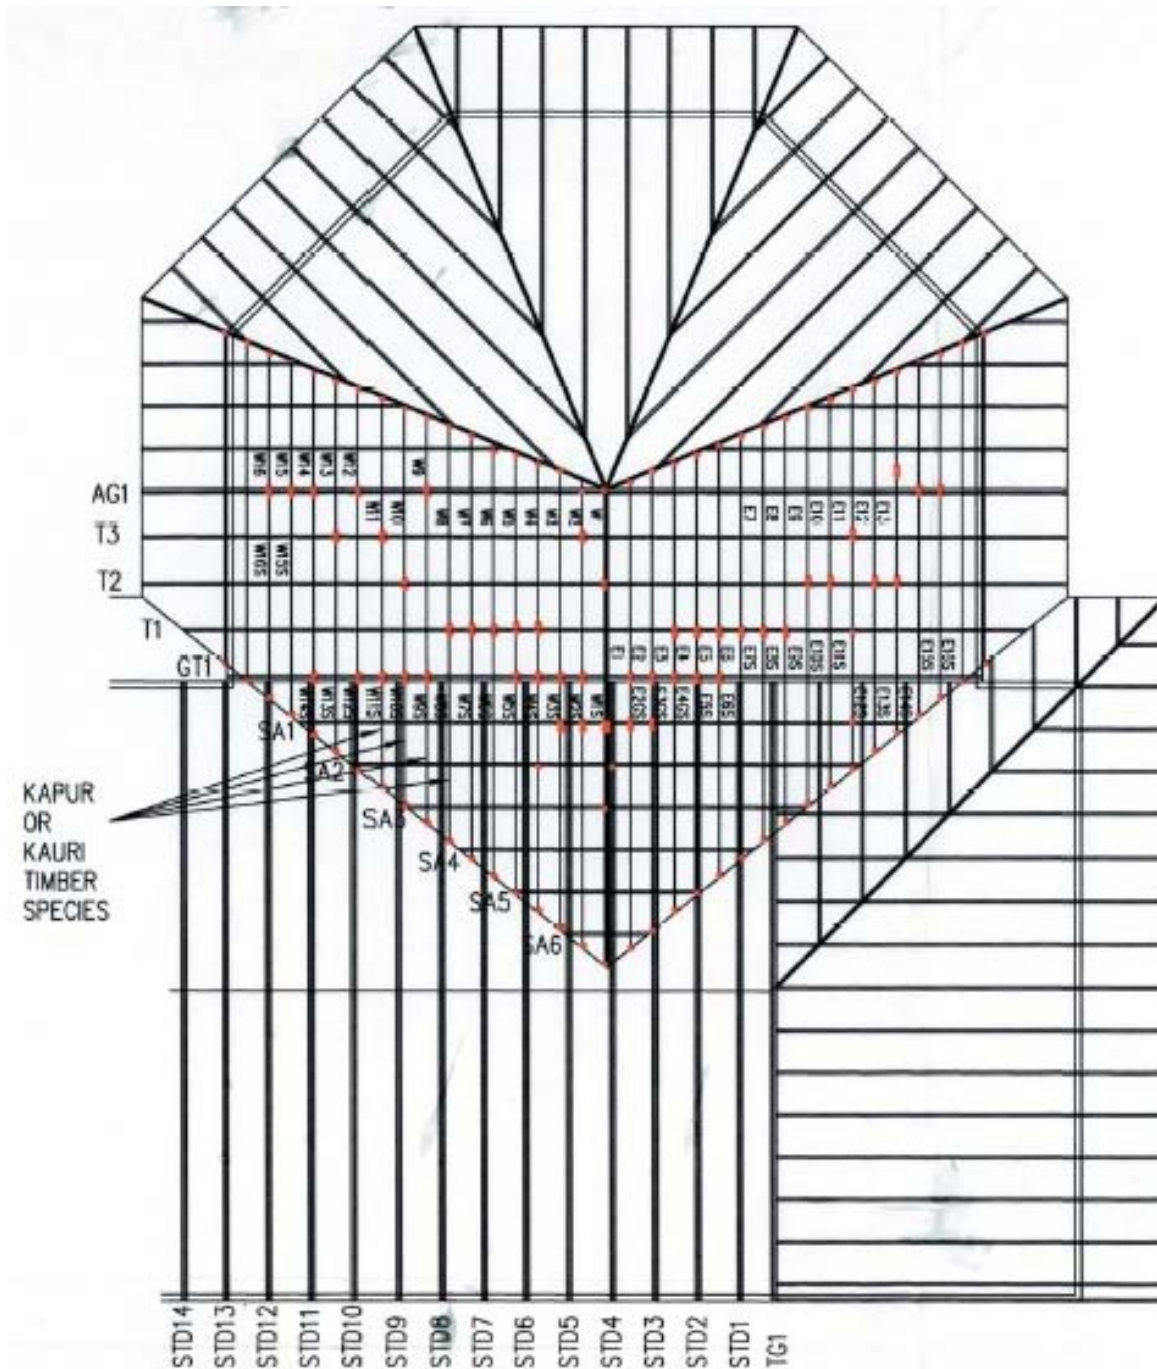
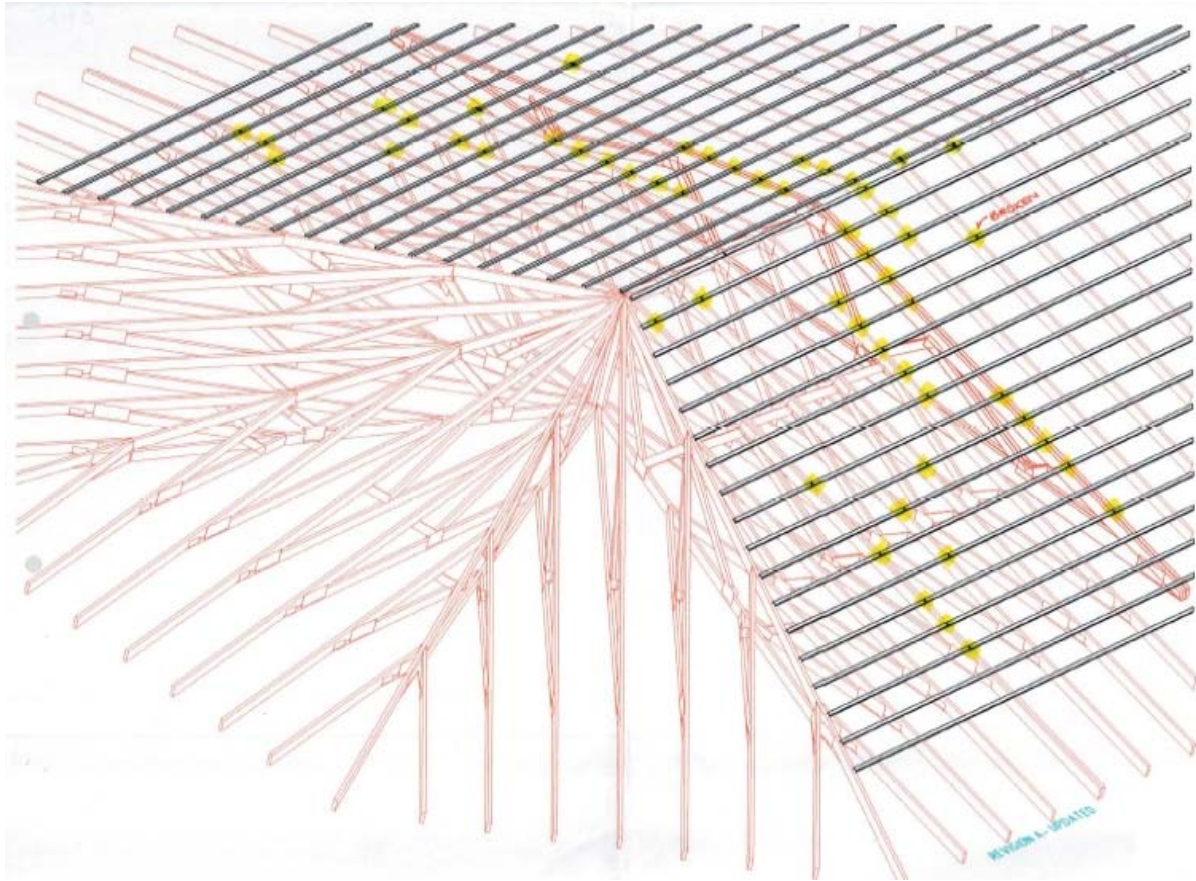
<sup>115</sup> Exhibit C41a appears above and Exhibit C41b appears on the next page

13.15. The evidence of Mr Goldfinch and of Mr Cooper satisfies me that there were a number of respects in which the attachment of roof battens to the double girder truss in this case was unsatisfactory. The evidence of Mr Mark Pickard, the Proprietor of Trussfab, who assisted Mr Goldfinch in the reconstruction of the structure after the collapse, vividly illustrates the defects in the attachment of roof battens. In Exhibit C41a and Exhibit C41b, diagrams produced by Mr Pickard, it can be plainly seen how many splices (joins) there were<sup>115</sup> (indicated by red dots).

13.16. Mr Pickard described the number of splices on the double girder truss as ‘very inappropriate ... terrible ... disgusting’<sup>116</sup>.

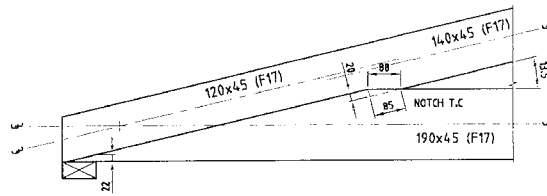
FIGURE 5: SKETCH OF FAILED DOUBLE GIRDER TRUSS (Scarf Cut)

- 13.37. It can be seen that in relation to the scarf cut demonstrated in Figure 5 above, there is only a thin sliver of timber from the bottom chord which becomes progressively narrower as the point of the heel joint is approached.
