INQUEST INTO THE DEATHS OF  
JOHANNA PAULINA MARIA HEYNEN  
AND MARILYN JEANNE MCDOUGALL

Finding of Inquest - Cause of Death

Inquest conducted by Mr Wayne Chivell, State Coroner, South Australia

**INQUEST INTO THE DEATHS OF  
JOHANNA HEYNEN & MARILYN MCDUGALL  
FINDING OF THE STATE CORONER**

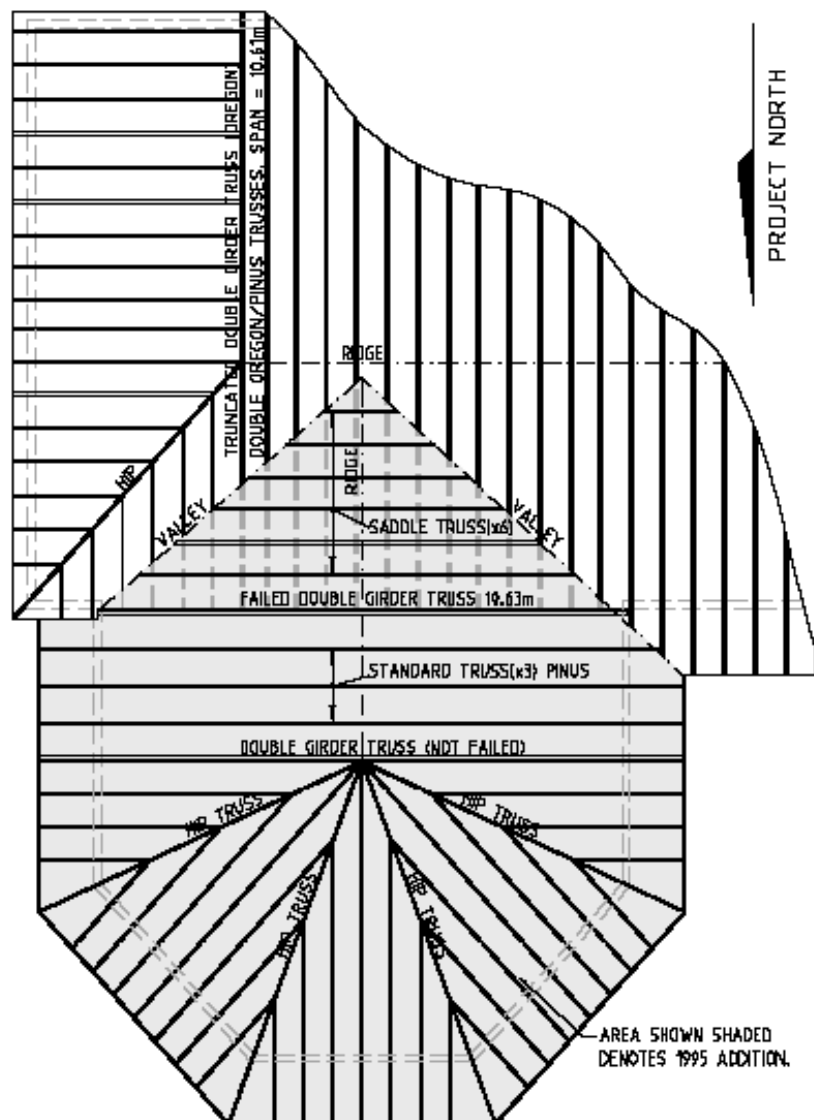
5.10. A plan of the timber roof trusses for the Riverside Golf Club construction is reproduced below<sup>33</sup>:

Mr Goldfinch said that on inspection of the collapsed roof on 2 April 2002, it was clearly apparent that a double girder truss had failed. The double girder truss in question was installed to replace a section of the northern external wall which had been demolished to provide an opening into the new extension<sup>34</sup>. He said:

The failed Double Girder truss was observed to have suffered a profound fracture at its western support end and also along its top chord member in the first panel down from the apex. Two nailplate joints connecting the Pinus web members to the bottom chord member west of the apex had also failed.<sup>35</sup>
