## FINDING OF INQUEST

*An Inquest taken on behalf of our Sovereign Lady the Queen at Adelaide in the State of South Australia, on the 1<sup>st</sup>, 2<sup>nd</sup>, 3<sup>rd</sup>, 4<sup>th</sup> and 24<sup>th</sup> days of September 2009 and the 27<sup>th</sup> day October 2009, by the Coroner's Court of the said State, constituted of Anthony Ernest Schapel, Deputy State Coroner, into the death of John Eric Mitchell and Graham Bryant.*

### **1. Introduction and background**

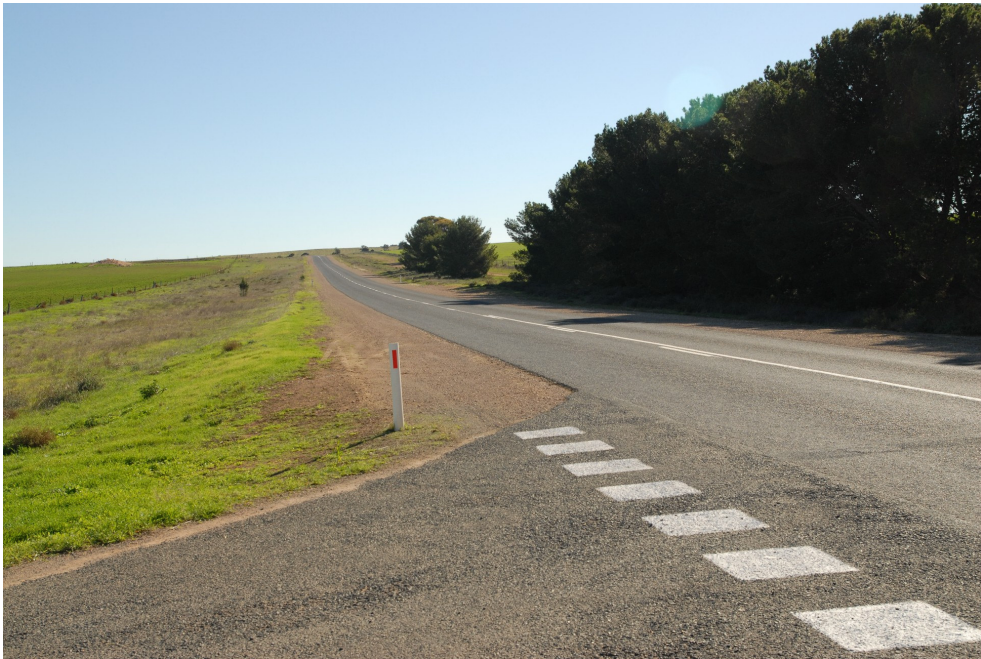
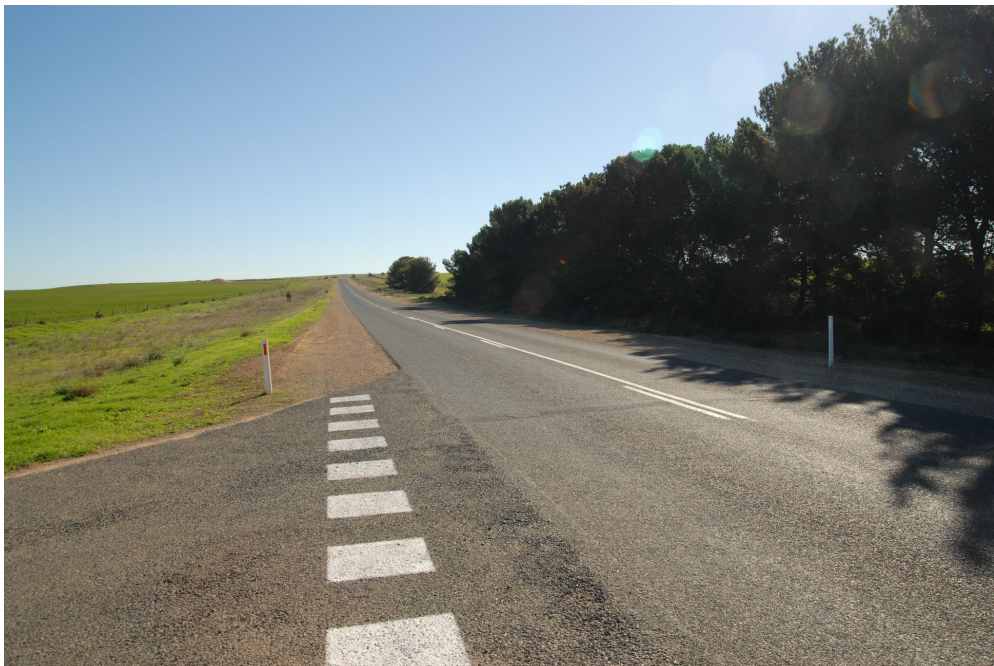
shadows thrown across the eastern carriageway in which Mr Bryant's motorcycle was travelling are minimal, except within the confines of the intersection itself. However, we are only concerned with what Mrs Thiele saw or failed to see before Mr Bryant actually reached the intersection. Far from demonstrating that Mr Bryant's motorcycle would have been obscured by shadow, there is very little evidence of shadow. What is shown is minimal and patchy and could not possibly have hidden from view even a dark coloured motorcycle being ridden at a speed that was not in excess of the limit. Two of Brevet Sergeant Keir's photographs are depicted below.

It is worthwhile observing that when Mrs Thiele was shown one of the photographs that were taken by Brevet Sergeant Keir<sup>27</sup> she was surprised to learn that it had been taken at the same time as the Bryant collision and at the same time of the year. She agreed that the photograph demonstrated that the trees did not in fact cast a great shadow over the road<sup>28</sup>.
